**Reconnaissance Following the October 15th, 2006
Earthquakes on the Island of Hawai'i**

**UNIVERSITY OF HAWAII
COLLEGE OF ENGINEERING**

Research Report UHM/CEE/06-07

October 26, 2006

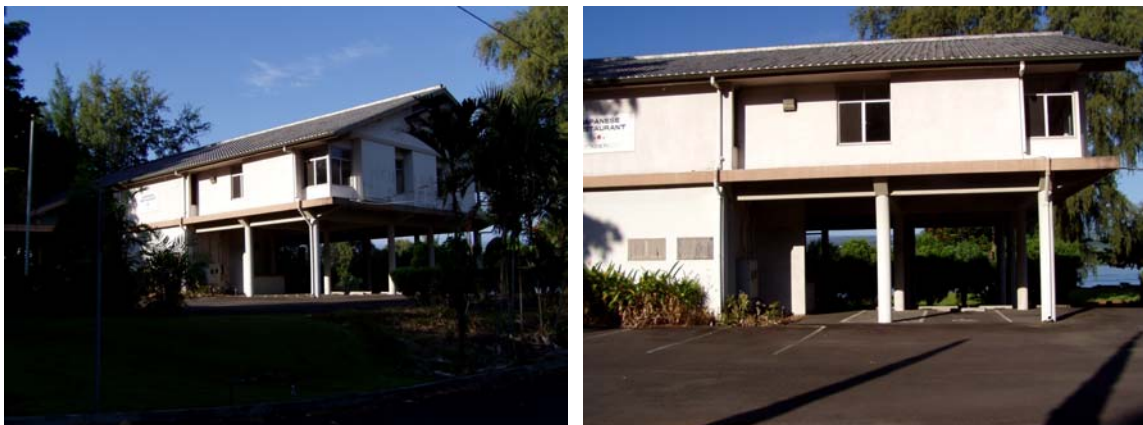
The Nihon Restaurant in Hilo consists of a two-story reinforced concrete structure with partial infill masonry walls at the ground level (Figure 13). Circular reinforced concrete columns and rectangular concrete beams at the first elevated level form a moment-resisting frame (MRF) for the first structural level. This MRF is relatively flexible compared with the infill masonry walls. No gap was provided between the walls and the frame to allow for this movement, resulting in diagonal cracking of the infill walls (Figure 14). Only minor cracking was noted at some of the MRF connections indicating that the building is structurally sound. The infill walls can be repaired and consideration should be given to providing a separation joint between the walls and surrounding columns and beams.

Figure 13: Nihon Restaurant, Hilo (B3).

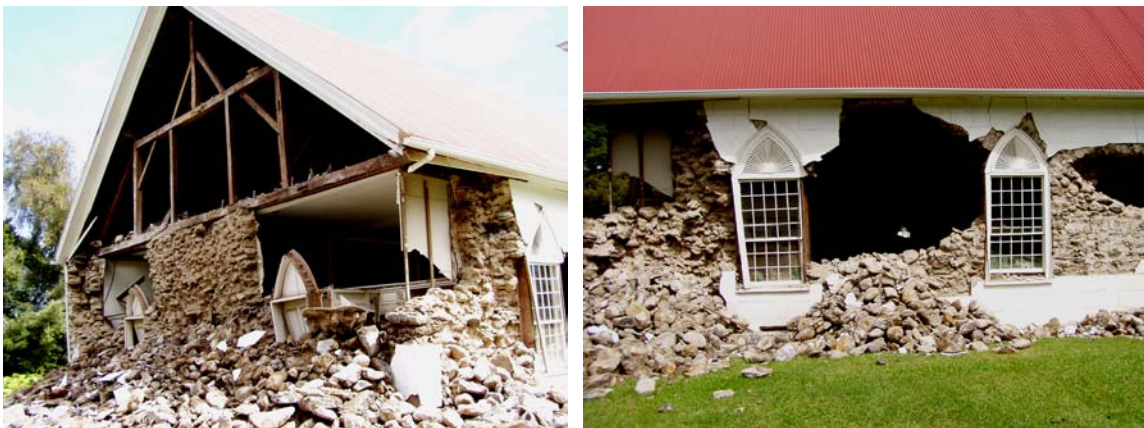
The historic Kalahikiola Church in Hawi, North Kohala, suffered extensive damage to the exterior rock-masonry walls supporting the roof trusses (Figure 17). Total collapse of the roof system appears to have been prevented by a single line of interior columns supporting the center of each roof truss and door and window frames supporting the eaves (Figure 18). The unreinforced rock-masonry walls were grouted with low-strength mortar, similar to many other rock-masonry walls built in the 19th and early 20th centuries (Figure 19). Many of these walls suffered damage in the form of cracking, partial collapse or complete collapse. The timber-framed bell tower appeared to have survived the earthquake with limited damage.

Figure 18: Roof trusses supported by interior columns and window frames after wall collapse (B7).

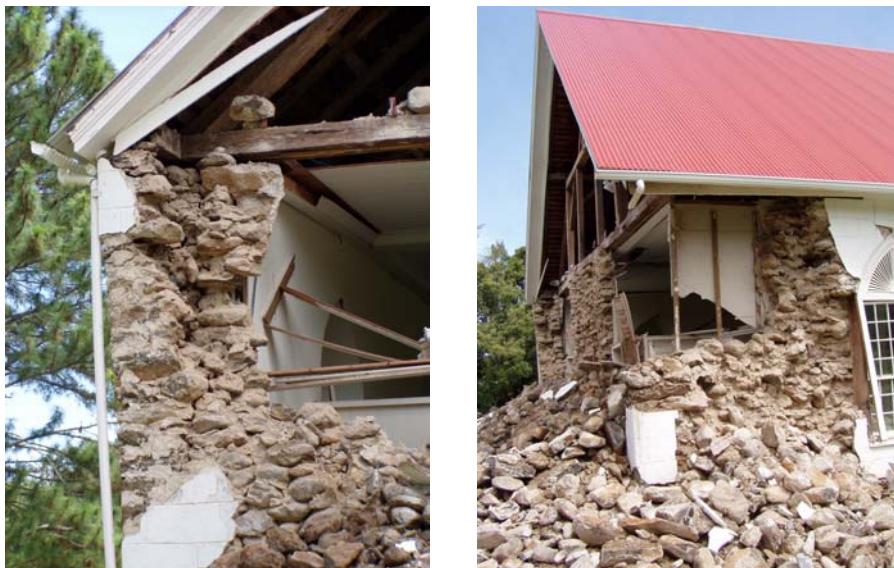
Figure 19: Unreinforced rock-masonry walls grouted with low strength mortar (B7).

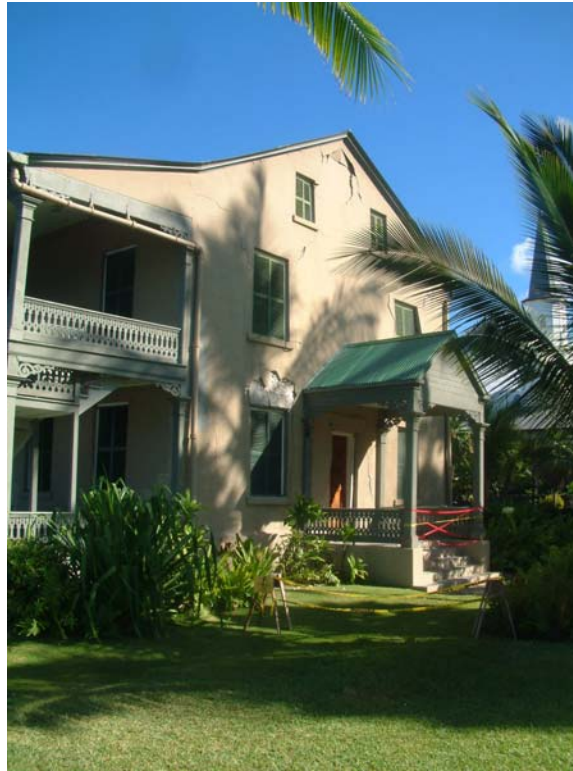
The historic Hulihe`e Palace in Kailua-Kona on the West side of the Island of Hawai`i suffered significant damage and was deemed unfit for use by State Civil Defense officials (Honolulu Advertiser, October 21, 2006). Typical diagonal cracking occurred in the exterior walls of the building, particularly around door and window openings (Figure 20). Our team did not inspect this building.

Figure 20: Hulihe`e Palace in Kailua-Kona (Photo by Gary Chock) (B8).

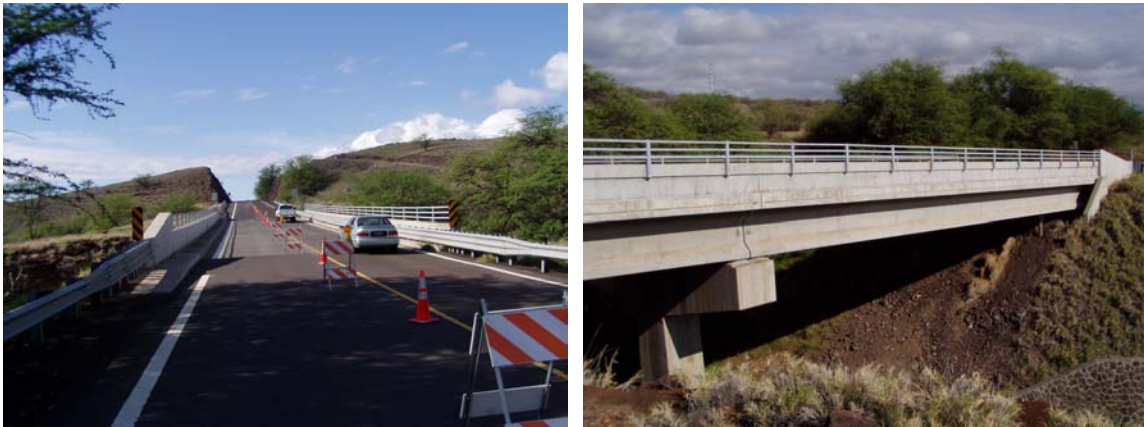
The Honokoa bridge, built in 1965, is located just North of Kawaihae on the West coast of the Island of Hawai'i. It is within 24 km (15 miles) of both earthquake epicenters. The bridge consists of two spans of simply-supported AASHTO prestressed concrete bridge girders supporting a reinforced concrete bridge deck (Figure 24). Figure 25 shows a schematic of the bridge cross-section. Significant damage was noted to the webs of the AASHTO girders at the abutments (Figure 26). Evidence of relative movement and pounding between bridge segments and between the bridge deck and the abutments was apparent from spalling damage to the bridge guardrails (Figure 27).

Figure 24: Honokoa Bridge (S1).

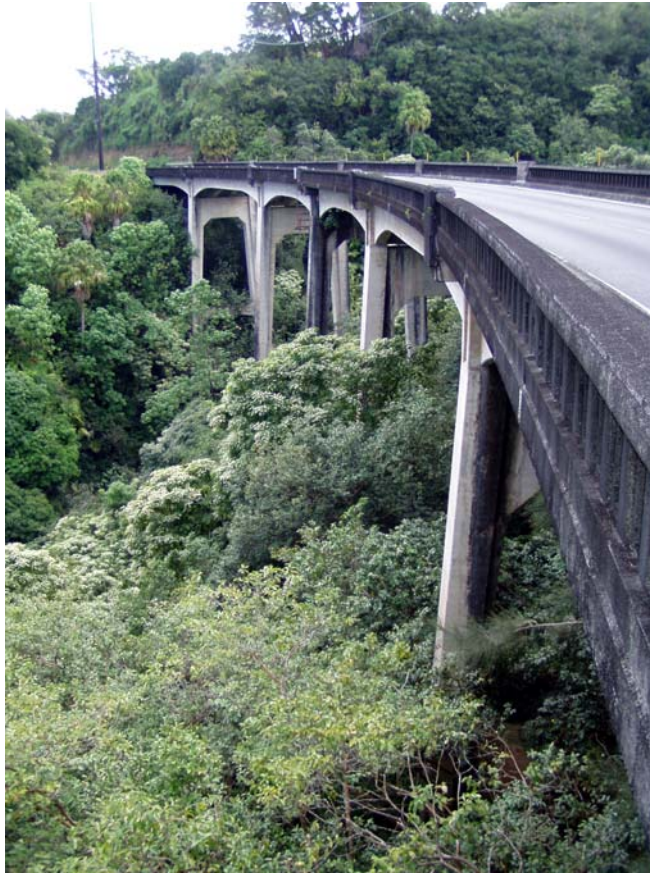
The Kealakaha Stream Bridge is a multi-span reinforced concrete girder bridge supported on two abutments and 5 reinforced concrete bridge bents founded in the deep gulch below the bridge (Figure 29). Because of seismic and operational deficiencies, the bridge is scheduled for complete replacement by a new three-span prestressed concrete bridge structure anticipated to start construction in early 2007. Although some distance from the epicenters of the October 15th earthquakes, there are signs of pounding between the bridge deck and the supporting abutment at the North end of the bridge (Figure 30). New cracking was noted in the corner of the abutment (Figure 31) and spalling had occurred at a number of the concrete pivot supports below the bridge girders (Figure 32). Some of these spalls appeared to have been initiated due to corrosion or other factors, but they were dislodged by the earthquake ground shaking. A minor slope failure was noted adjacent to the North abutment, but did not appear to affect the abutment stability. The bridge remains open to traffic.

Figure 29: Kealakaha Stream Bridge (S2).

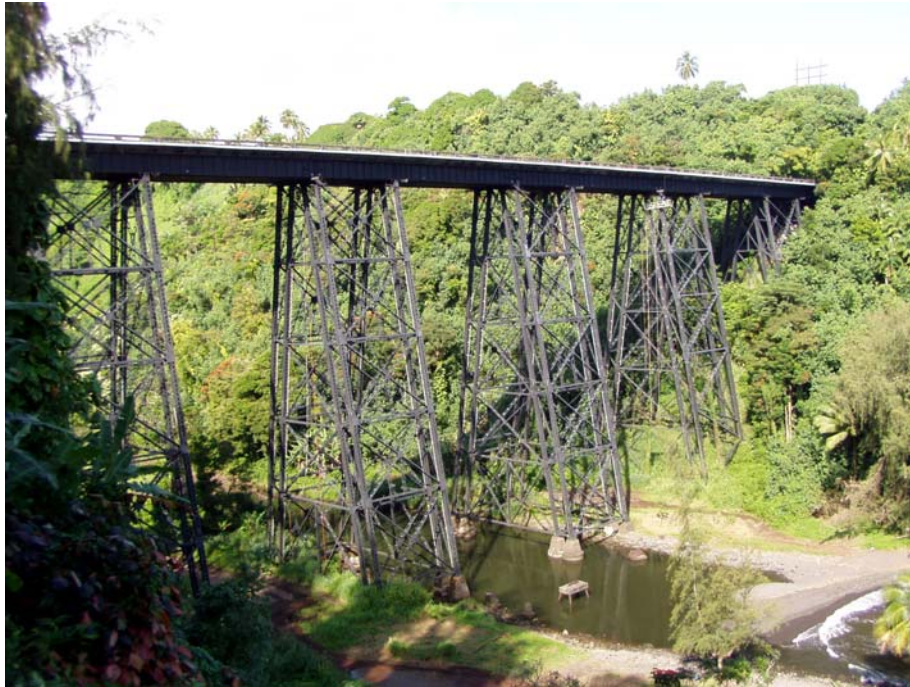
A number of bridges along the island beltway (Route 19) North of Hilo consist of complex steel lattice construction typified by the bridge shown in Figure 33. These bridges have all been analyzed per current AASHTO seismic design provisions and retrofitted when deemed necessary. An example of the retrofit is the addition of restraint cables to prevent unseating of the steel plate girders (Figure 34). A detailed inspection of this bridge structure was not performed during this reconnaissance trip. The bridge remains open to traffic, as do all similar bridges along Route 19.

Figure 33: Steel Trestle bridge on Route 19 North of Hilo (S3).

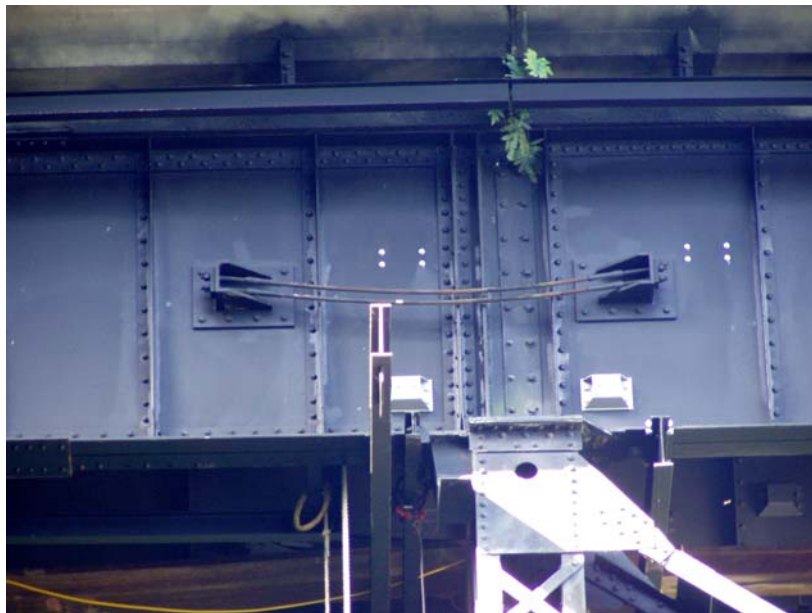
Figure 34: Cable restraint retrofit of bridge plate girder joint (S4).

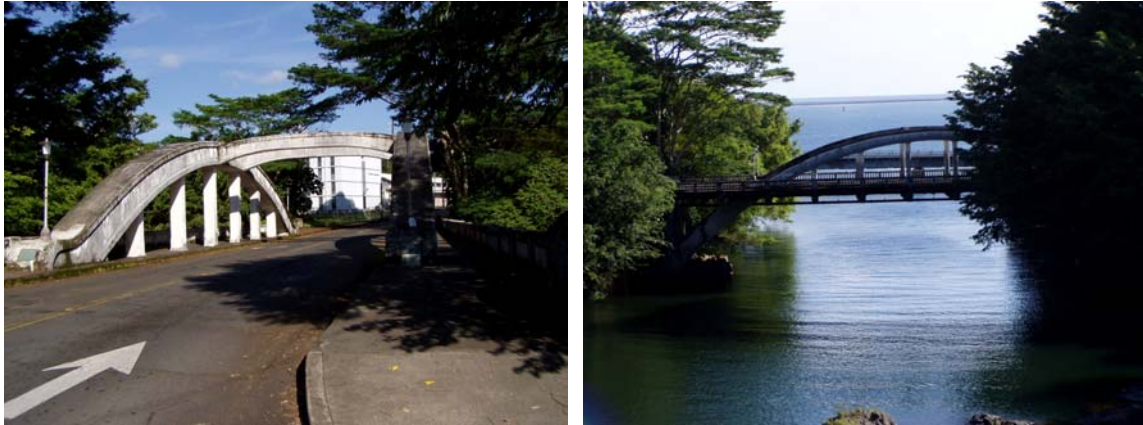
A number of historic concrete bridges in Hilo were inspected briefly during this reconnaissance trip (Figure 35). No signs of damage were noted.

Figure 35: 1938 Keawe-Wailuku Arch Bridge in Hilo (S4).

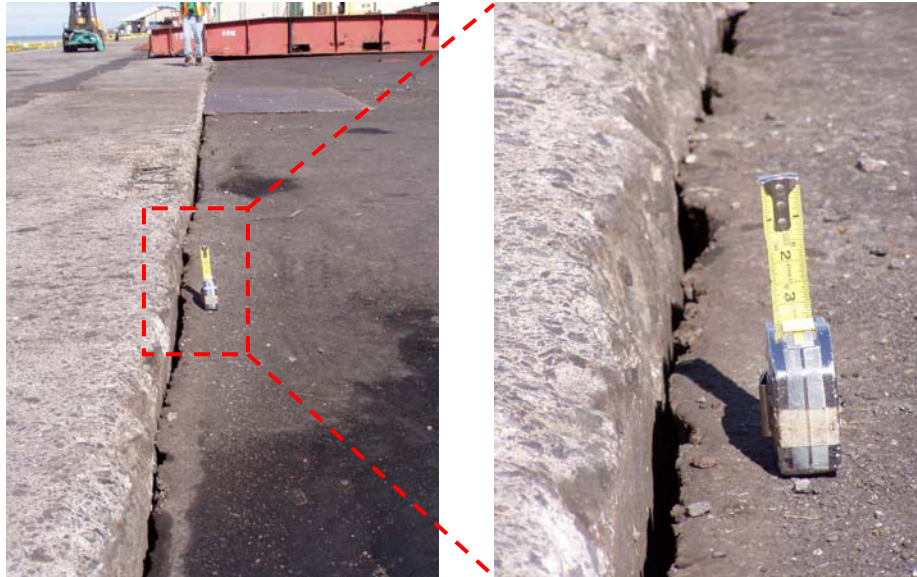
The commercial port facility at Kawaihae Harbor consists of two pile-supported concrete piers, the older Pier 1 to the North and Pier 2 to the South, and an asphalt paved shipping container yard. Large areas of the asphalt yard, which is constructed over dredged fill, had settled up to approximately 6 inches (Figure 39 and Figure 40). Fine sand had been ejected from cracks in the asphalt pavement and through junctures between the paved fill area and the pile-supported concrete pier (Figure 41). A series of cracks with widths ranging from approximately 1/4 inch to several inches were observed roughly aligned parallel with the shoreline (Figure 42). Cumulatively, these cracks displayed lateral spreading of 6 inches or more. Personnel at the facility described fine sand and water “squirting out of the cracks” in the pavement immediately following the earthquakes. These personnel also described enlargement of the spreading cracks over a period of one to two days following the earthquakes.

Figure 40: Liquefaction induced differential settlement between pile-supported pier on left and asphalt pavement on fill (H1).

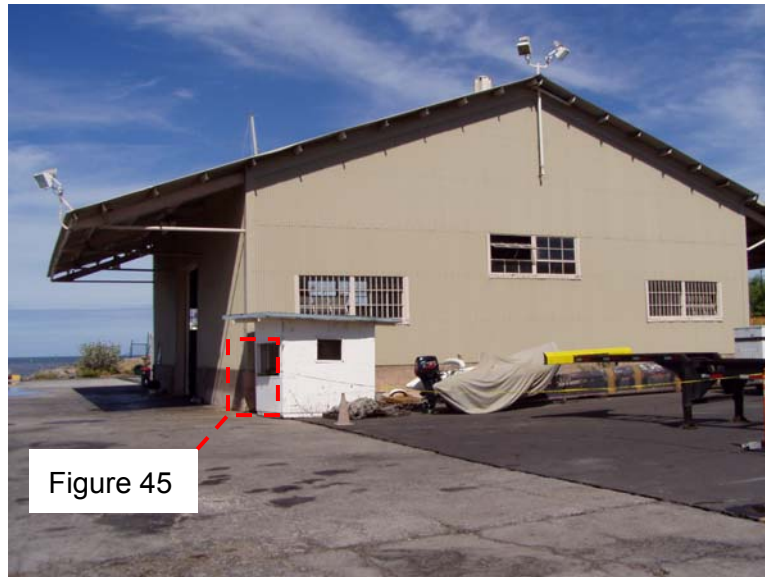
Three warehouses on Piers 1 and 2 are constructed of pre-manufactured metal frames with sheet metal cladding (Figure 44). Since the seaward columns are all supported on the concrete piers, while the landward columns are supported on foundations in the fill material below the approach paving, the metal frames had spread to accommodate the lateral movement of the piers. Figure 45 shows the resulting opening in the unreinforced concrete masonry unit (CMU) wall at the South side of one of these warehouses on Pier 1. The interior view of this warehouse shows that the column lateral movement resulted in shear failure of the two bolts securing the end of the first horizontal girt (Figure 46).

Figure 45: Separation in CMU wall at corner of warehouse (outside and inside views) (H1).

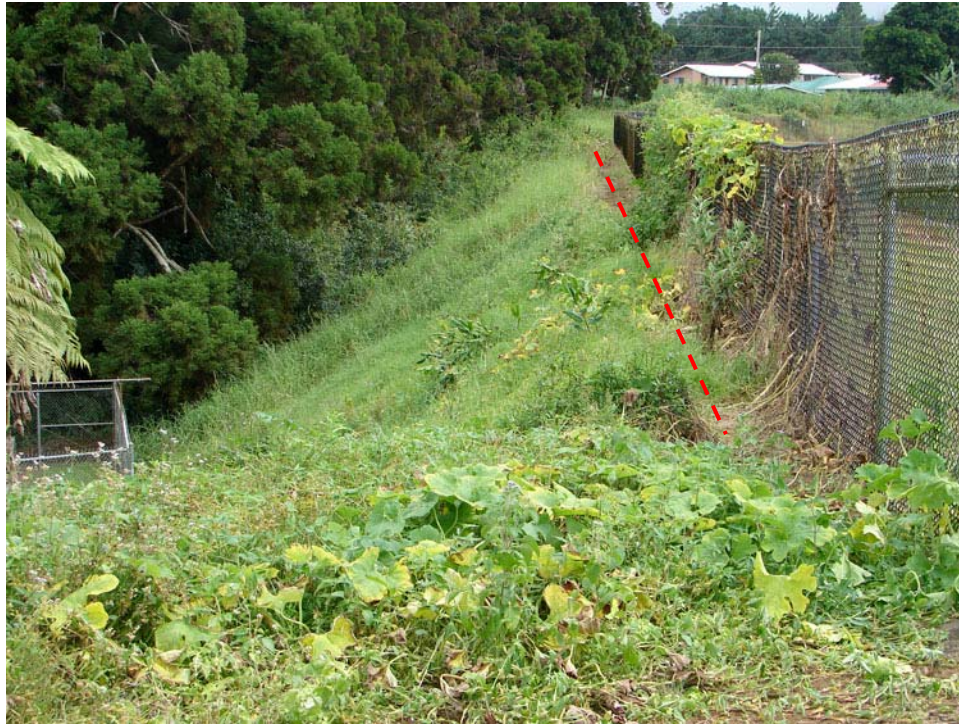
The other major reservoir system in the area consists of the circular Waimea 60MG reservoir, which is connected to the 120 MG Puu Pulehu reservoirs by a buried pipe. The latter reservoir developed significant cracking where the crest of the embankment transitions to the outside slope (Figure 53 and Figure 54). Damage occurred along the steepest portion of the embankment (about 1H:1V or somewhat steeper), with the system of cracks extending some 135 feet parallel to the crest. Displacements of the cracks showed both lateral and vertical components of approximately 2 inches at the surface, clearly indicating incipient slope failure. Even larger cracking of the same nature was reported for the Paauhilo reservoir, located further away from the epicenter.

Figure 53: Downstream slope of Puu Pulehu reservoir embankment (about 1H:1V) (D2).

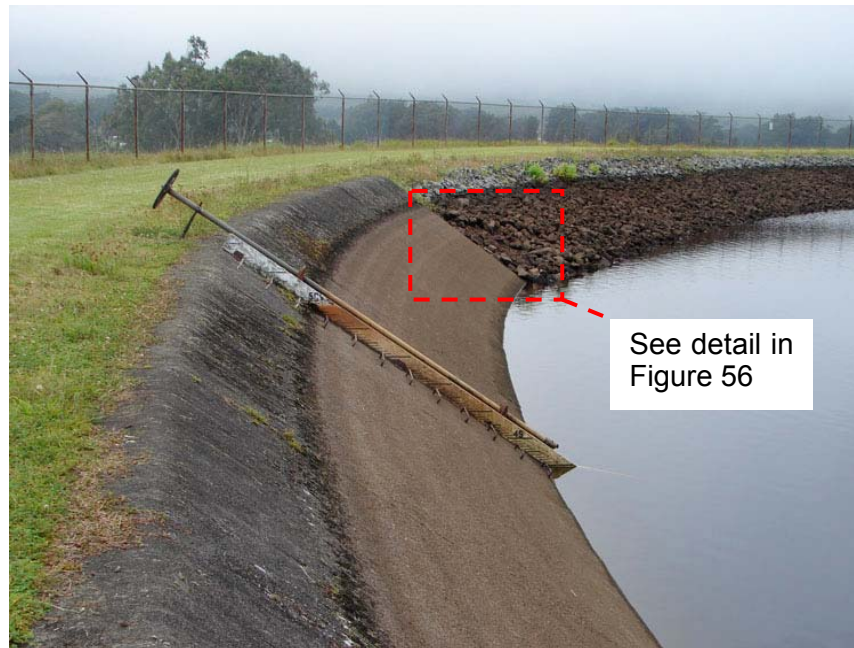
The Waimea reservoir fared relatively well, except for some minor sliding of the rock rip-rap on the inside slope of the embankment (Figure 55), along with cracks in the soil beneath (Figure 57). Some of the ditches that feed these reservoirs were blocked by debris and suffered damage that made them inoperable for a few days.

Figure 55: Waimea 60MG reservoir showing concrete and rip-rap lining (D3).

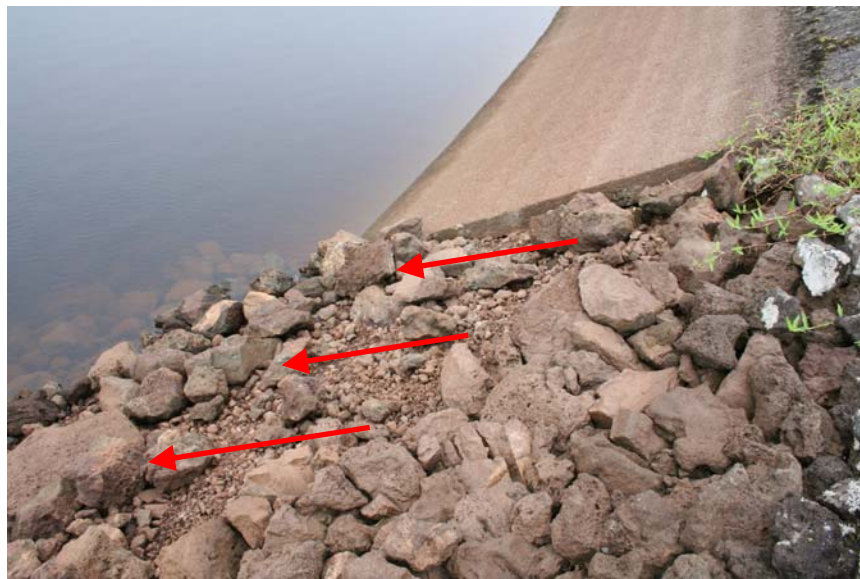
Figure 56: Sliding of rock rip-rap lining at Waimea Reservoir (D3).

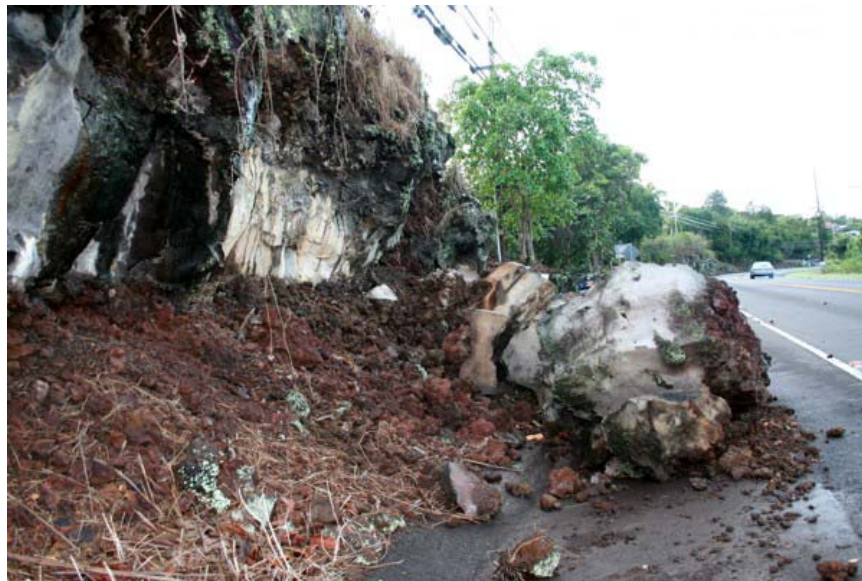
Figure 62: Example of discontinuous geology where dense basalt rock overlies weaker and less stable clinker (R3).

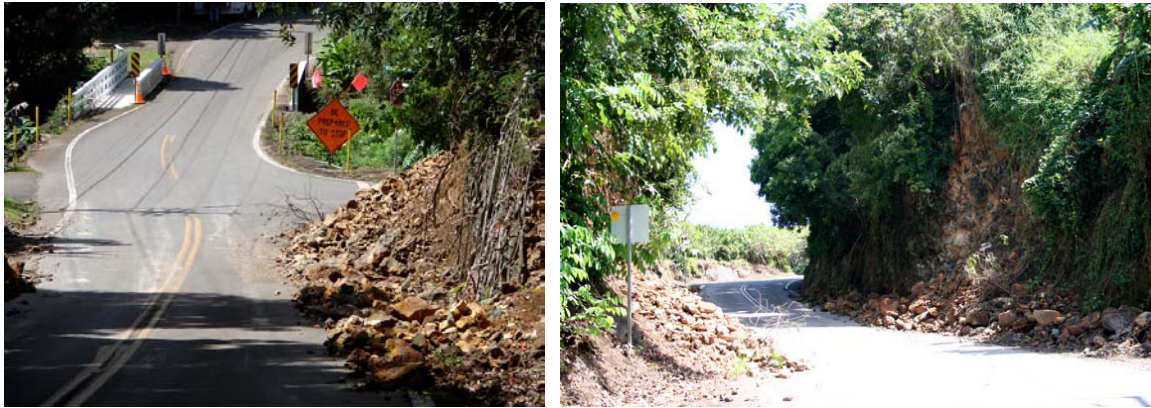
Figure 63: Example of single road access to northern end of North Kohala that was temporarily closed due to sliding; one-lane bridge in background (R5).

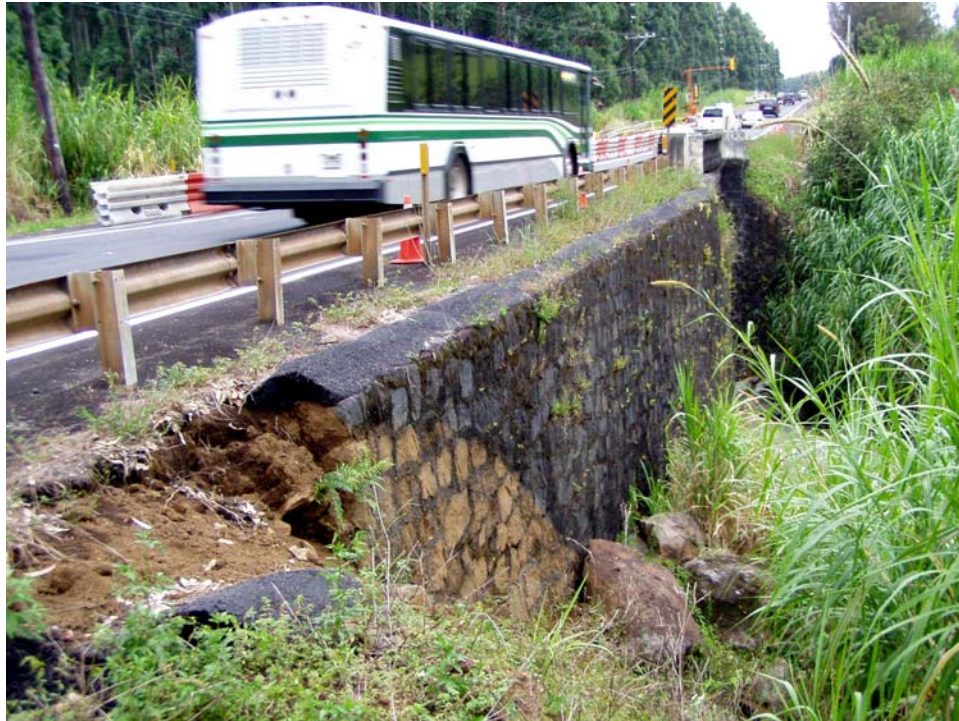
Figure 68: Similar mortared rock wall on opposite side of collapsed embankment (R7).

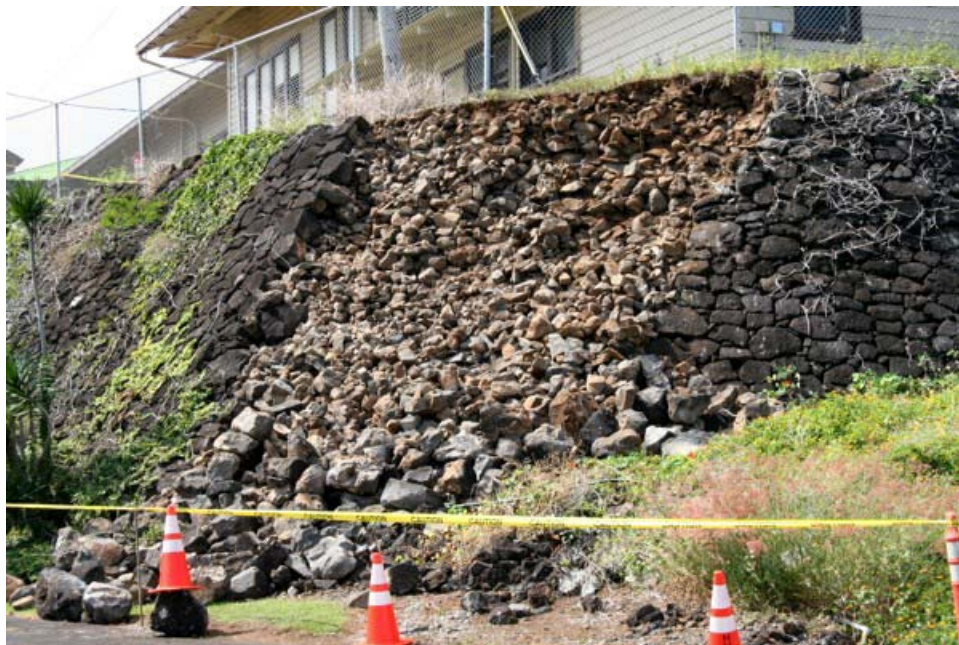
resulting in the closure of one lane of traffic (Figure 65 and Figure 66). This was caused by failure of a 20-foot high embankment and rock wing wall on the approach to a concrete girder bridge. The cast-in-situ concrete girder bridge is supported on rock wall abutments as shown in Figure 67. The bridge suffered no damage but the adjacent embankment failed. The wing wall consisted of mortared rock and was approximately 14 inches thick similar to the other side of the roadway (Figure 68). A number of unmortared rock walls collapsed elsewhere (Figure 69), while many well-built rock walls performed satisfactorily. One reinforced concrete retaining wall in Honokaa was observed to have failed due to poor foundation support (Figure 70).

Figure 69: Collapse of un-mortared and unreinforced retaining wall in Honokaa (R8).
